Radiocarbon dating of roof timbers from Cryfield Grange

As previously reported, tree-ring dating of the reused timbers from the roof of the north wing of Cryfield Grange was unsuccessful, because the timbers had too few rings or failed to match. Dating by radiocarbon was therefore commissioned and the results have finally been received.

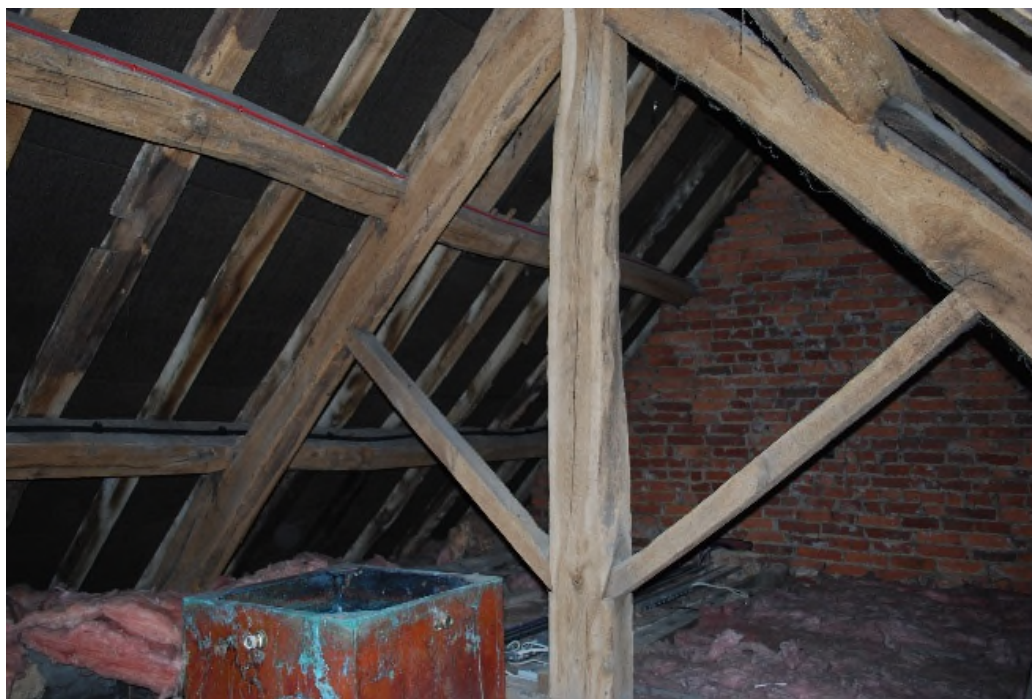
Fig. 4. The roof over North Range, showing some reused smoke-blackened rafters and the 18th-century king-post roof truss. [Photo: Alex Russell]

The early features in this range have only been examined very cursorily, and no survey has been undertaken. In summary, the surviving features in the roof are the smoke-blackened rafters, some with halved joints (Figs. 4 and 5).

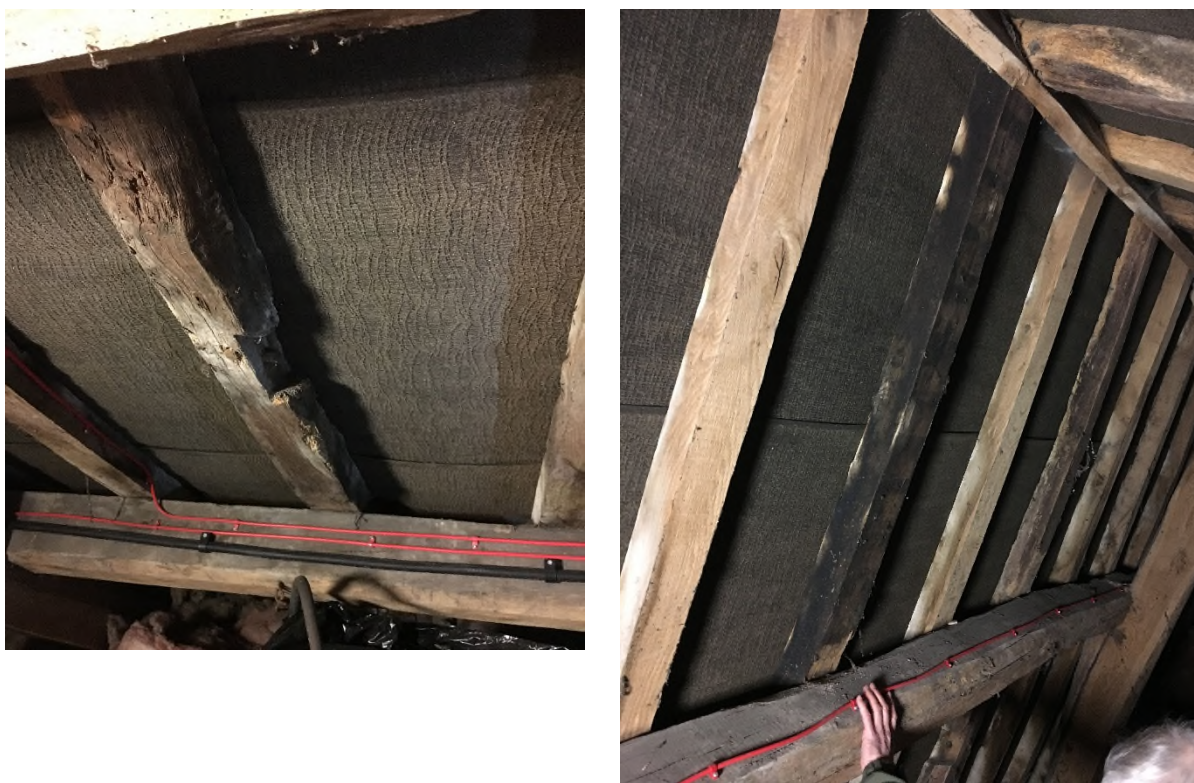
Fig. 5. (a) [left] halving in reused rafter; (b) [right] heavily smoke-blackened rafter. [Photos: Alex Russell]

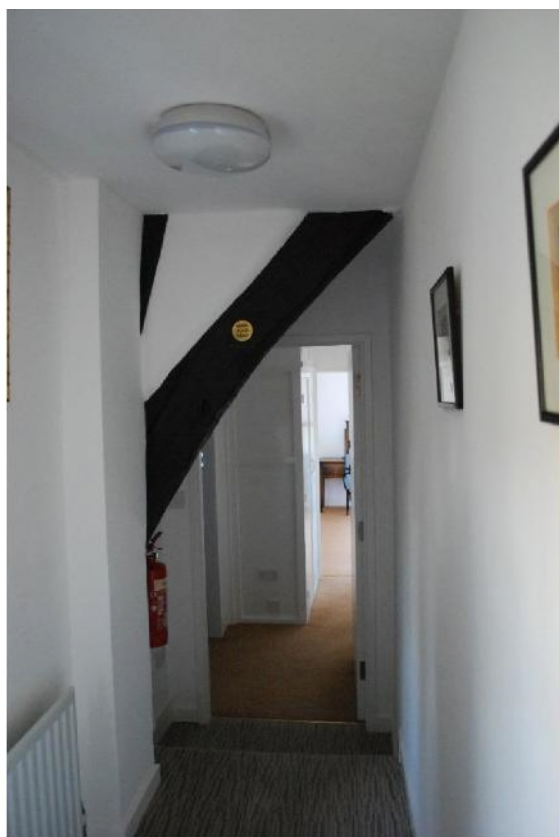
Fig. 6. Arch-brace and post head of remaining timber-framing on the west side of the north range [Photo: James Edgar]

Within the brick walls of the north range, wallposts and arch braces survive on the west side, presumably with tiebeams still *in situ* (to which the arch braces must be attached) (Fig. 6).

Surprisingly, it seems that wallposts on the east side were not retained, although the structure has not been examined closely, to see if they could be hidden within later walls. We can presume that these posts also date to the first half of the 14th century – it is implausible that a 14th-century roof, which can only have been replaced at the end of the 18th century, would have been retained above a timber-frame of later date.
