Energy & Low-Income Tropical Housing – ELITH Working Paper EWP IIB-8-1**Interlocking Mortarless Bricks: Column Straightness and Stiffness Testing, Data-set A****African Field Course 2009. Project C Report, Excerpt pp 10-25****McDonald M, Stegman A, Coker L, Maxwell A, Simmonds M, Taylor N***This experimentation was performed on the campus of URDT, Kagai, Uganda****Introduction***

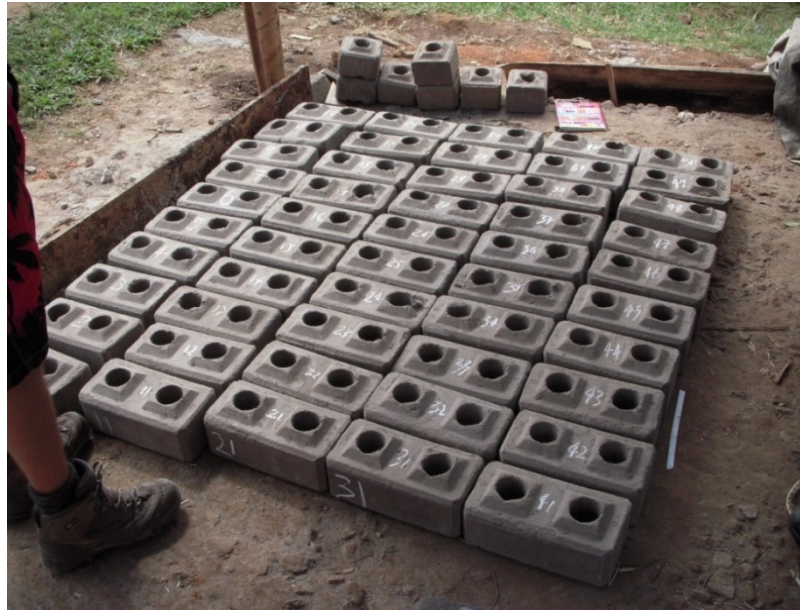
Figure 2 – Sample of 50 stabilised soil bricks used in tests.

A sample of 50 stabilised soil interlocking bricks was used in these experiments, selected from a batch made one year ago by the previous field course group. The bricks were manually pressed at URDT in Kagadi using a modification of the CINVA-Ram press machine. The 50 bricks selected from the batch were those that appeared to be in best condition and any that had not been formed correctly or had suffered severe damage were rejected. The bricks were numbered from 1-50 (as shown in figure 4) to aid the process of selecting random brick combinations and also to facilitate repeat stacking of the same tower across the different sets of tests.

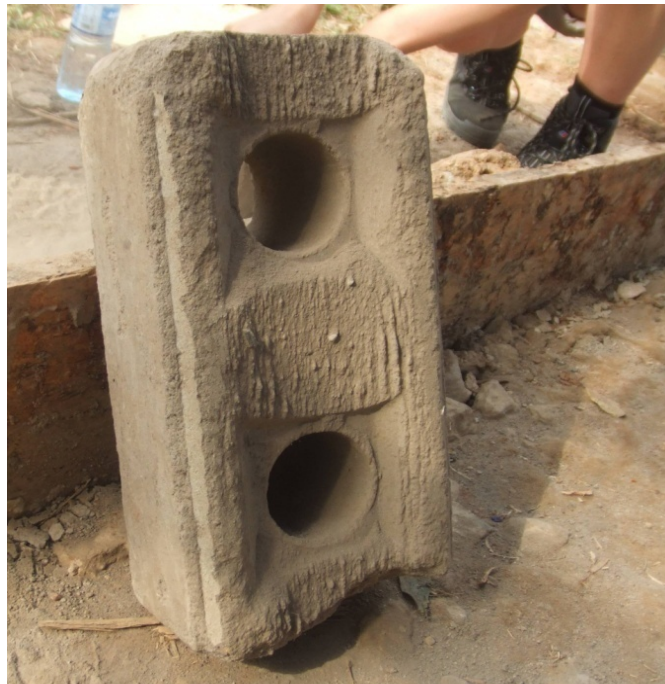
Figure 3 – Brushed brick

Bricks were taken from the sample and brushed using a wire brush to create a groove along the centre of the bottom surface (see figure 2). This meant that only two thin strips along the edges made contact with the top of the brick below. The bricks were then stacked with random orientations.

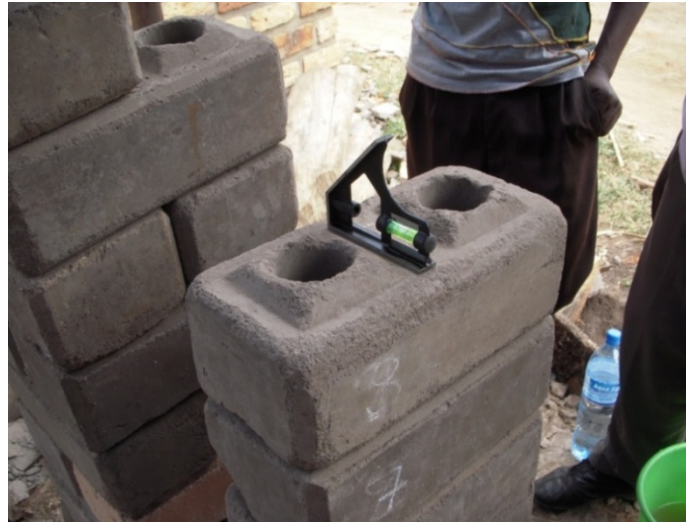
Figure 4– Levelling process

The same brushed bricks were used as in Set 2 but this time a system of optional reversing was employed when stacking. Each brick was first stacked one way and the level of the top surface measured using a spirit level. The orientation was then reversed and the level was measured again. The final orientation of the brick was chosen as the one which created the most level top surface. This process of levelling was repeated as each brick was added to the tower.

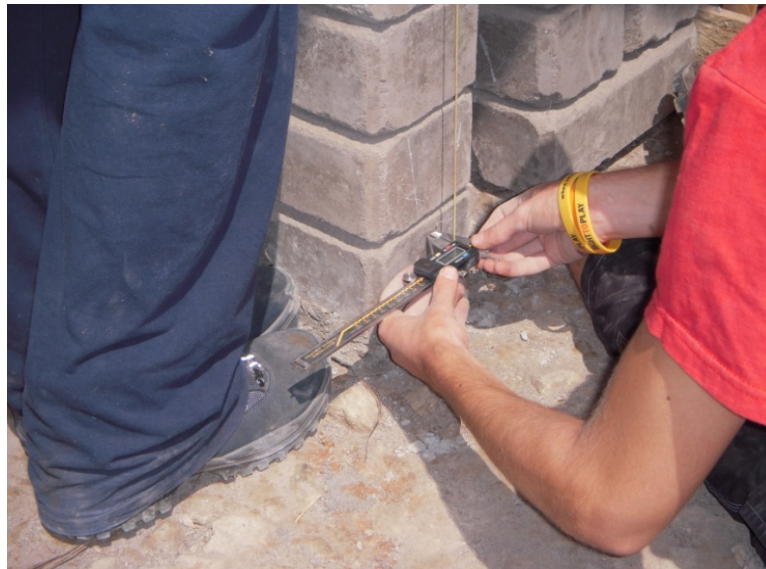
Figure 6 – Measuring out of plumb displacement using digital calipers

The test towers were constructed in line with the procedures set out in section 4 above. The width of the bottom brick was measured using a ruler, and the centre line of the brick marked on using a thin pen line. The centre of the top brick of each tower was also measured and marked on using a nail to create a narrow groove in the top edge. A plumb line was slowly lowered through a wooden block held in place at the centre of the top brick until the metal weight at the bottom hung just a couple of millimetres from the floor. The plumb line was held in place until any oscillation had died away and the string was as close to stationery as could be achieved in the test conditions. Digital calipers were then placed between the centre line and the string of the hanging plumb line in order to measure the out-of-plumb deviation in millimetres (see Figures 7 & 8 below).

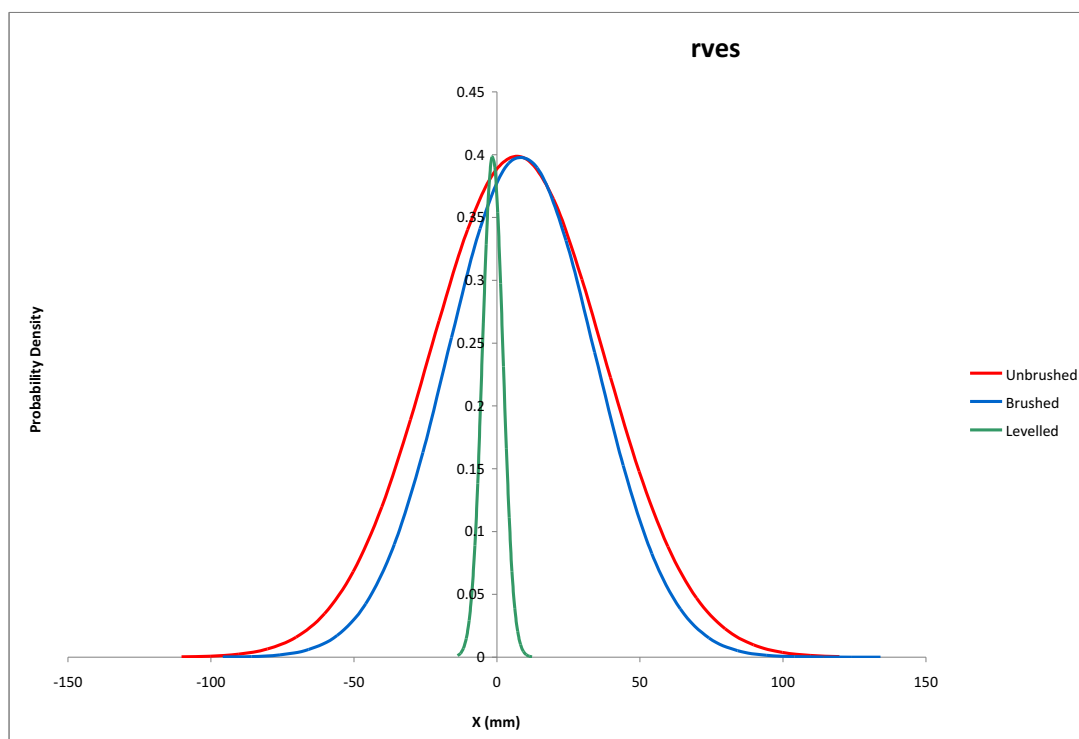
Figure 7 – Normal Distribution Curves for Straightness Results

The calculated functions were then used to plot the normal distribution curves for the three sets of tests: unbrushed, brushed and levelled (see Figure 9).

the straightness of towers. This is reflected by the wide spread of the normal distribution curve, shown by the red line in Figure 9. This agrees with the prediction that the poor dimensional accuracy of interlocking bricks creates a high level of variability in the straightness of columns and walls.

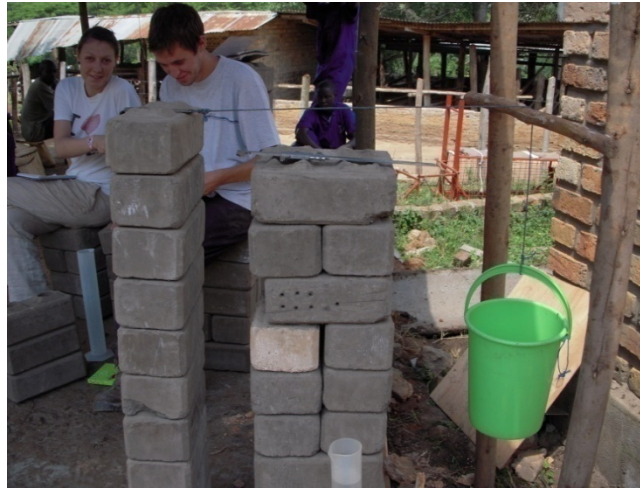
Figure 9 - Photograph of Stiffness Test Rig

As testing was taking place in Uganda, typical testing procedure could not be followed as the apparatus available was limited. Therefore a test setup comprising of a bucket and hook was arranged in order to allow for a gradual increment of load (Figure 2). A frame was constructed by driving two wooden poles into the soil in front of the test tower and fixing a horizontal pole between the two at a height of 1.2m, the same height as the test towers (See Figure 11). Before it was fixed in place the horizontal pole was carefully levelled using a spirit level. A length of string was tied to the handle of a plastic bucket and hung over the horizontal pole. A right angle hook was fabricated by bending a strip of sheet metal and drilling a hole in one end. This was attached to the other end of the string and was hooked over the top of the 10 storey tower in order to act out the worst case scenario of a lateral load applied at the top. This will produce failure at the lowest loading, thus giving an indication of the lower bound load limit. Load was increased by adding water to the bucket at fixed volumes using a measuring cylinder. The actual load acting on the wall could then be determined using Equation 2:

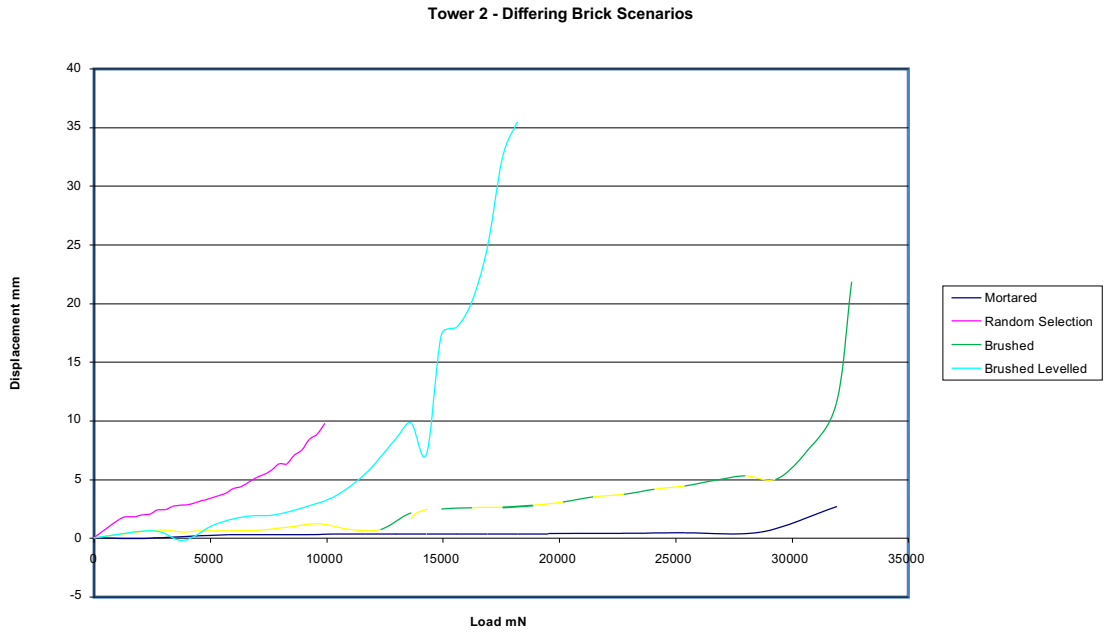
Figure 10 – Load-Displacement graphs for the different laying strategies used to construct Tower 2

The graph in Figure 12 shows clearly the increase in stiffness of the towers when the bricks were brushed. It also indicates the relatively small difference in force required for failure for the brushed and mortared towers. On careful observation, small plateaus are visible of the towers sudden increase in displacement with a small increase of load, before a long flat period where the increase in load has little effect on the position of the tower.

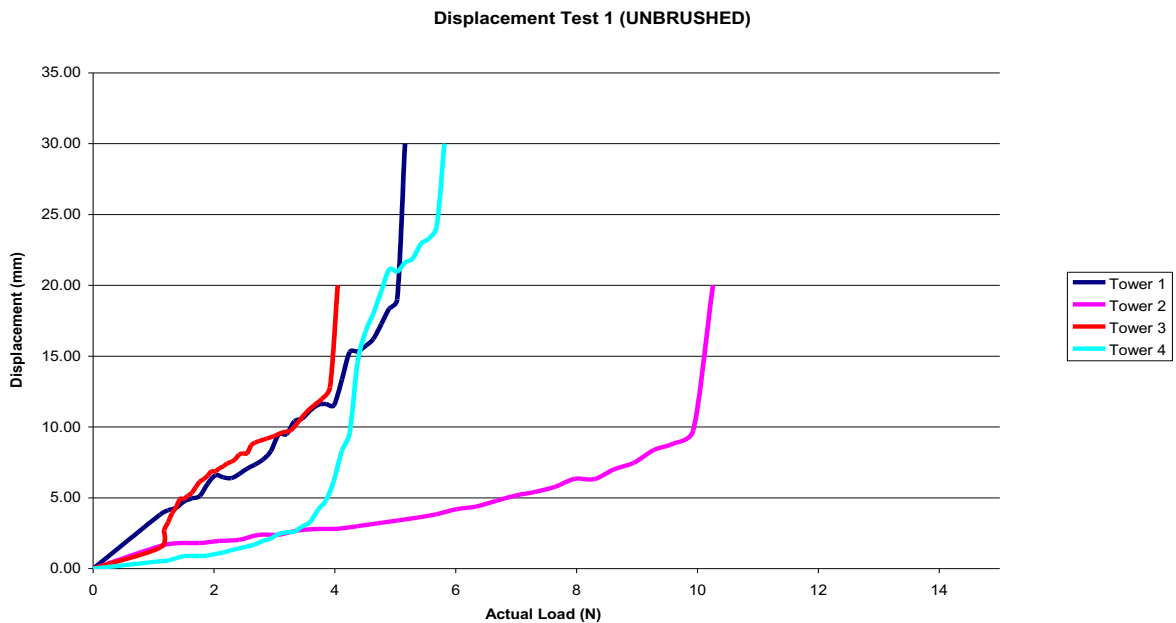
Figure 11 – Load-Displacement Graphs for the 4 towers tested

Figure 13 shows the large variation in displacement patterns for the 4 towers tested in Set 1. Tower 2 held a considerably larger load before collapse than tower 3. It also indicates the displacement spread before collapse with towers 1 and 4 moving 10 mm further before collapse than towers 2 and 3. Finally Figure 13 also shows the sudden displacements followed by long periods of no movement of the towers.
