EXTERNAL SPACES HEALTH & SAFETY INFORMATION SHEET

FACULTY OF ARTS – 3RD FLOOR BALCONY

Date survey undertaken: Friday 10th Maisuria 2023 10am

Prepared for
University of Warwick
Coventry
CV4 7AL

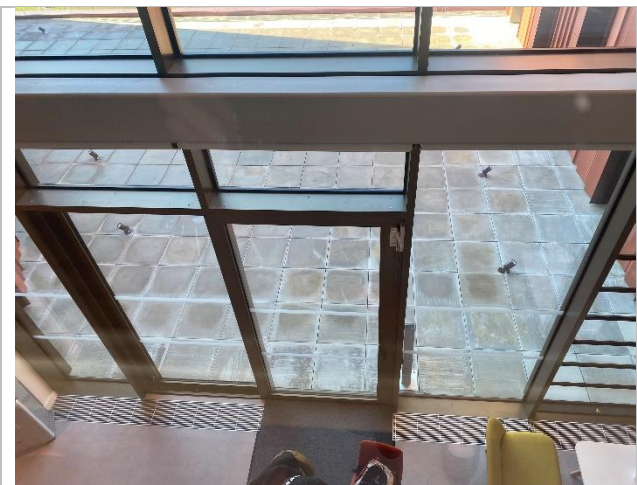
Main access door from lobby on the third floor shows key and Salto access.

5.1 There is access on to the balcony from one main access door. This a key and Salto access door from the 3rd floor inner hallway. The balcony has one outer frontage and can be directly viewed from office spaces which surround the area. There is currently no general access permit system in place for this outside space but we would recommend one be put in place.

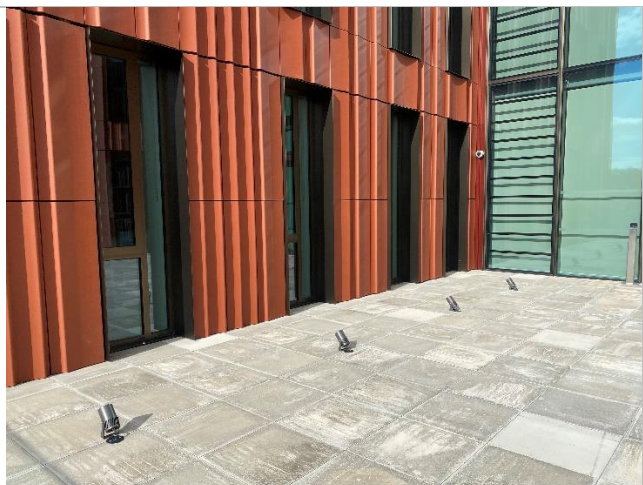
- 8.1 The balcony area is finished with profile concrete pavers and well maintained and is surrounded by approximately 2-metre-high edge protection. It has external lighting that are proud of the floor surface. These may be a trip hazard.
- 8.2 This balcony is for contractor access only, at this point of writing this report we were notified that social events would not be taking place on this balcony area.
- 8.3 There is currently no plant equipment on the balcony area. Weather conditions should be taken into account especially wind levels which could increase the probability of injury from pre-existing hazards when working at height.

Main balcony area, window access onto balcony area from surrounding office space. External light provision shown.

10.2 There is external lighting that points out to the edge of the balcony area, there may be the need for additional lighting dependent on work taking place. In winter months it may need additional lighting dependent on weather conditions and timing of event.

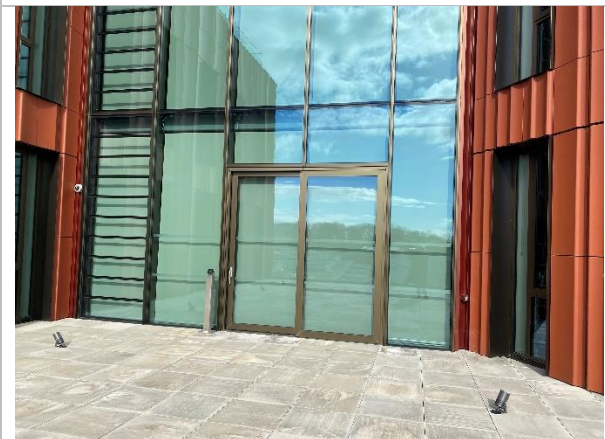
Main double Salto access doors from balcony space.
