## **Flat Roof Pre-access Hazard Identification Report**

### **01.017 SENATE HOUSE**

Date undertaken 7<sup>th</sup> December 2023

University of Warwick,  
Coventry,  
CV4 7AL

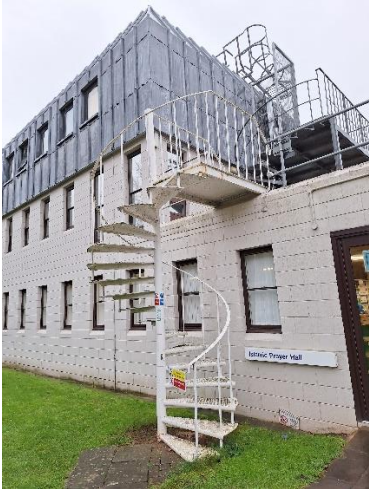
Northern side external stairwell

**3.2** The roof can be accessed via the white spiral staircase on the northern side of the building. To access the south side of the lower roof, an S1 key is required to unlock the gate that covers the stairs round the back of the building/main entrance doors.

**9.4** The white spiral staircase used to access part of the lower roof can be slippery when in damp conditions. Consideration should be made to ensure correct and appropriate footwear is worn.

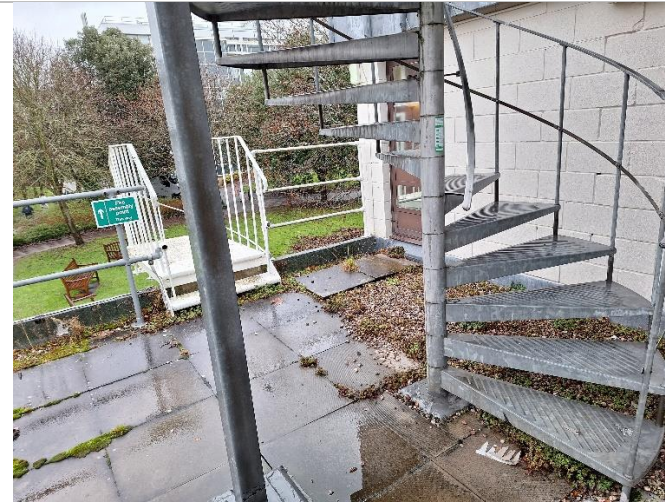
Galvanised stairwell from lower roof to vertical ladder and slabs

**3.3** Once at the top of this staircase, proceed up the galvanised steel spiral staircase to reach the vertical ladder.

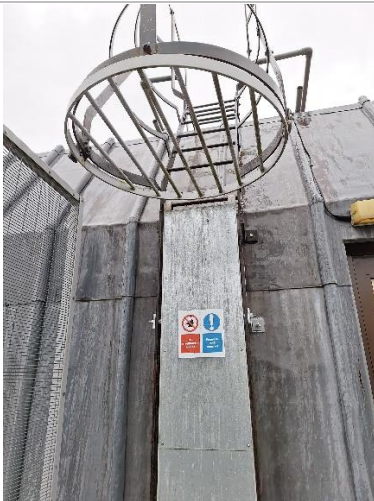
Vertical Ladder up to main roof with Salto padlock

**3.4** Using your roof Salto fob, unlock the ladder shield and pull back the plate to reveal the ladder rungs and make your way up to the main part of the roof.

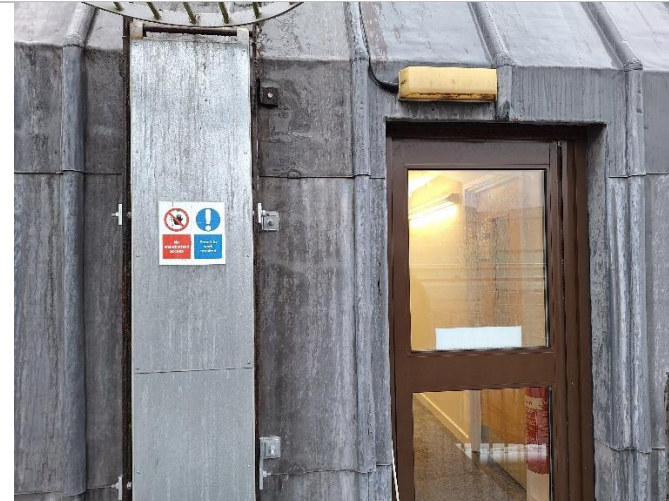
Internal 2<sup>nd</sup> floor fire escape/roof access

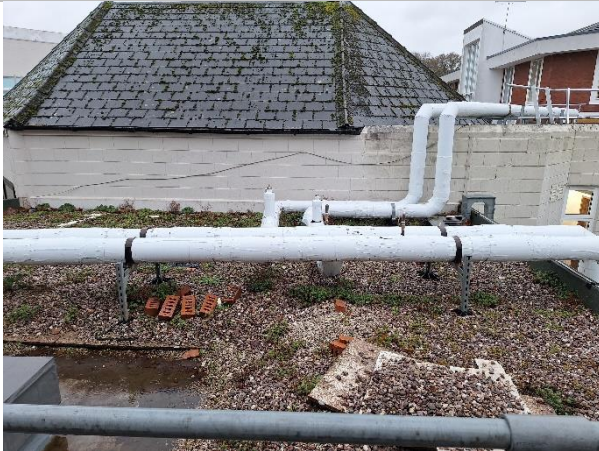
Example of pipework and loose articles beyond edge protection

**9.5** If the need to venture beyond the edge protection is necessary, some of the roof contains trip hazards like debris and pipework.

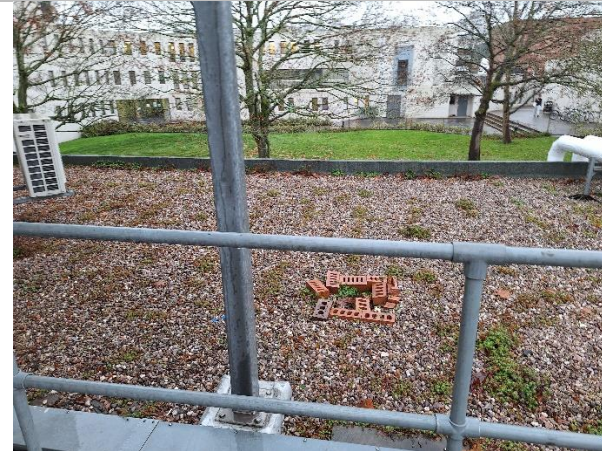
Loose ballast beyond edge protection on lower roof.

**9.1** Slips, trips and falls around the site. There is a set out walkway for the main part of this roof, the rest it is open plan. The roof flooring comprises of gravel and loose ballast on the main roof, which may be unsteady under foot. The lower levels are a mixture of slabs and loose ballast.

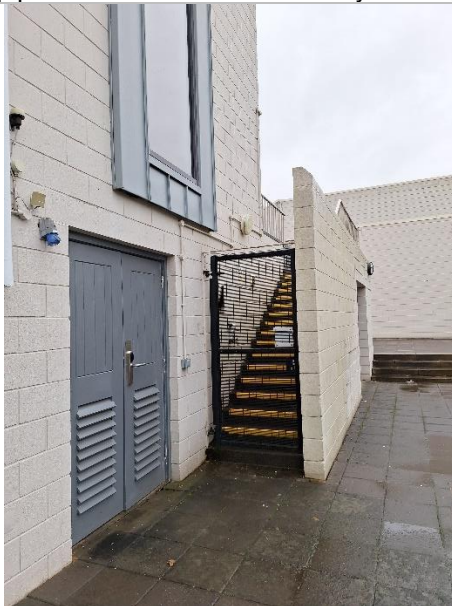
Southern side entrance gate to lower roof (next to plant room)

**3.6** On the southern side of the building (next to the plant room) there is another staircase which can be used to access the lower levels of the roof also. An S1 key is required to gain access through the gate.
