Flat Roof Pre-access Hazard Identification Report

01.042 PHYSICS

Date undertaken 25th October 2021

Building 01.042 Physics, Central Campus

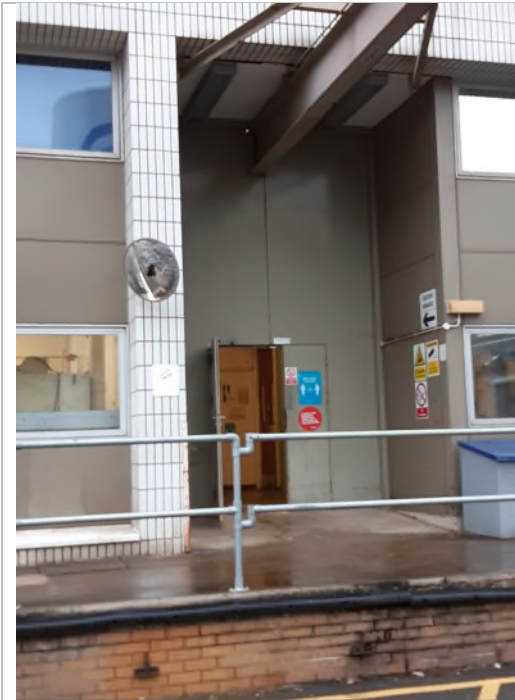
'Goods Inward' entrance into Physics

- 3.2 When you reach Physics, you will need to approach from the south-westerly side and access the building via the loading bay through the double doors marked 'Goods Inward' (see photos). There is no reception to sign in at this building.

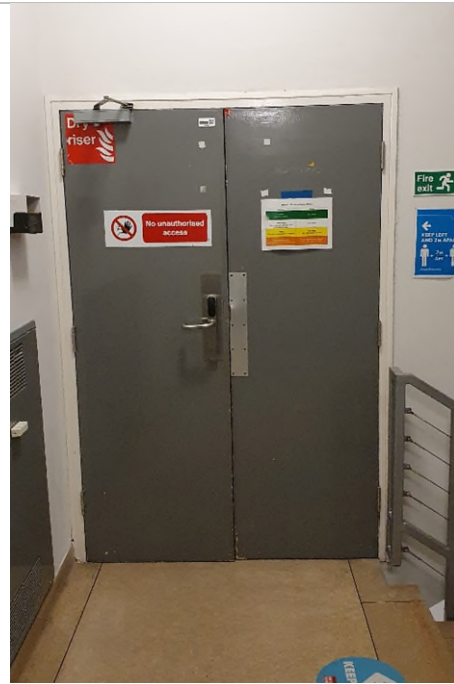
Plant room door on 5th floor

- 3.3 Go straight ahead through the next set of doors where you proceed up the stairs on your left to the fifth floor (or a goods lift is available on the right if you need it). Once at the top of the stairs turn right and you will see a door marked 'No unauthorised access' (see photo). Use the Salto card to open this door and proceed up the stairs into the main plant room (note this is a working plant room where other staff may be carrying out work). Turn right and walk to the end of the plant room where you will find a white double door on the left with a Salto lock. The roof door is opened with the Salto access card. There is a metal step down onto the roof, which is mainly slabbed.

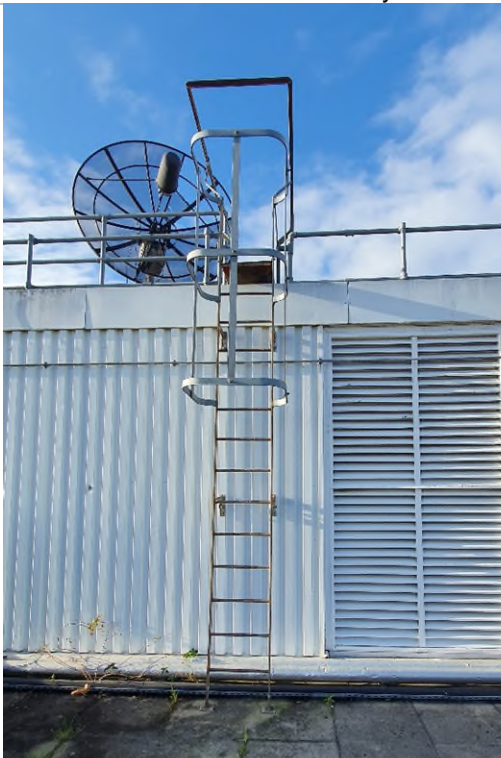
Access ladder to upper roof and departmental antenna

9.5. Falls from height: Access to the upper roof is via a fixed, hooped, metal access ladder. Adequate consideration must be given for transporting tools, equipment and materials onto the roof while maintaining three points of contact on the ladder.

9.7. Unknown hazards from departmental equipment: There are various antennae and telecommunications equipment on the upper roof and one to the rear of the main roof. Advice should be sought from the Building Manager before planning work near this equipment.

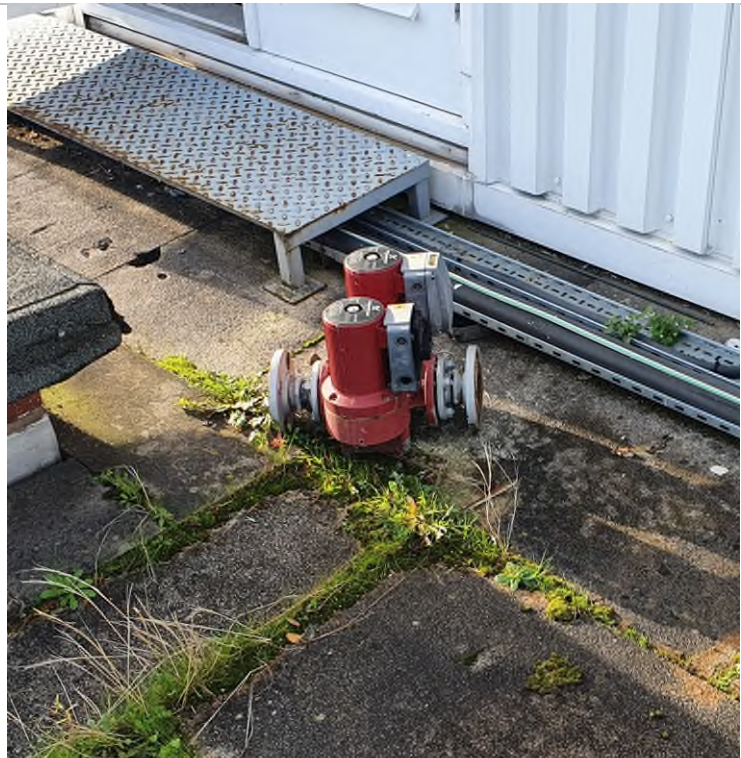
9.2. Slips, trips and falls around the site: the plant room is frequently used by departmental and Estates staff and there are sometimes tools and materials on the floor. On this visit, an old pump set had been left on the roof directly outside the plant room door (see photo).

Discarded pump set

5.5. Waste must be collected and disposed of appropriately by the Competent Person. If the Competent Person is an external contractor, they should remove any waste from the site and dispose of it according to their company policy. University employees should remove any waste or redundant equipment from the roof area and dispose of it according to University policy and guidance.

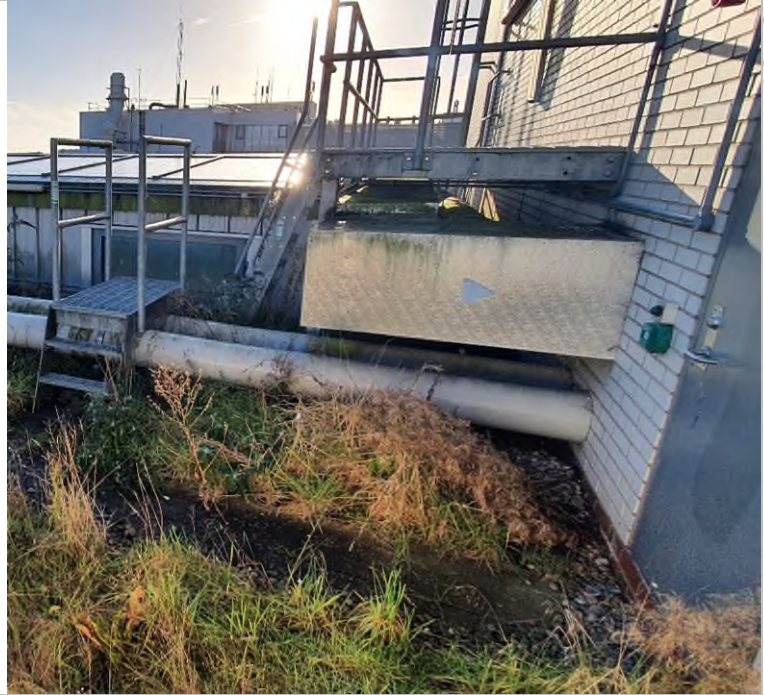
9.1. Slips, trips and falls around the site: The roof is slabbed and the surface of the slabs may become slippery during wet or icy weather, especially if moss or weeds are allowed to build up, of which there was some evidence (see photos). There are two roof levels. The main, lower roof has a lot of plant including AHUs, chillers, fume cupboard stacks so there are a lot of trip hazards in the form of cable trays, trailing cables, ducts, pipework, ventilation outlets as well as uneven slabs and changes in levels. The edge barrier supports provide an additional trip hazard.

Steps onto MASB roof, ladder to upper roof and weeds on Physics roof

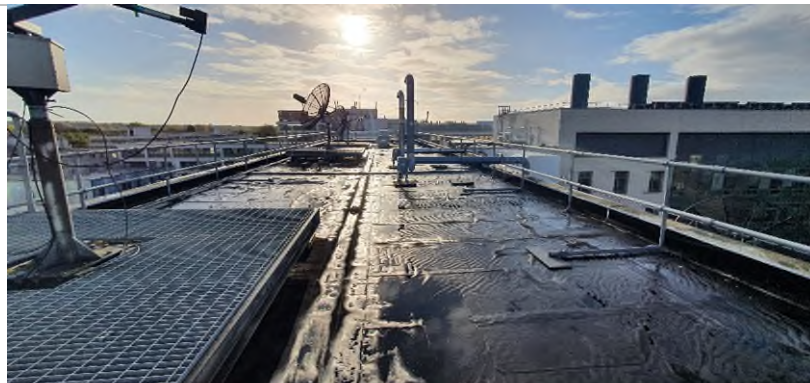
Upper roof

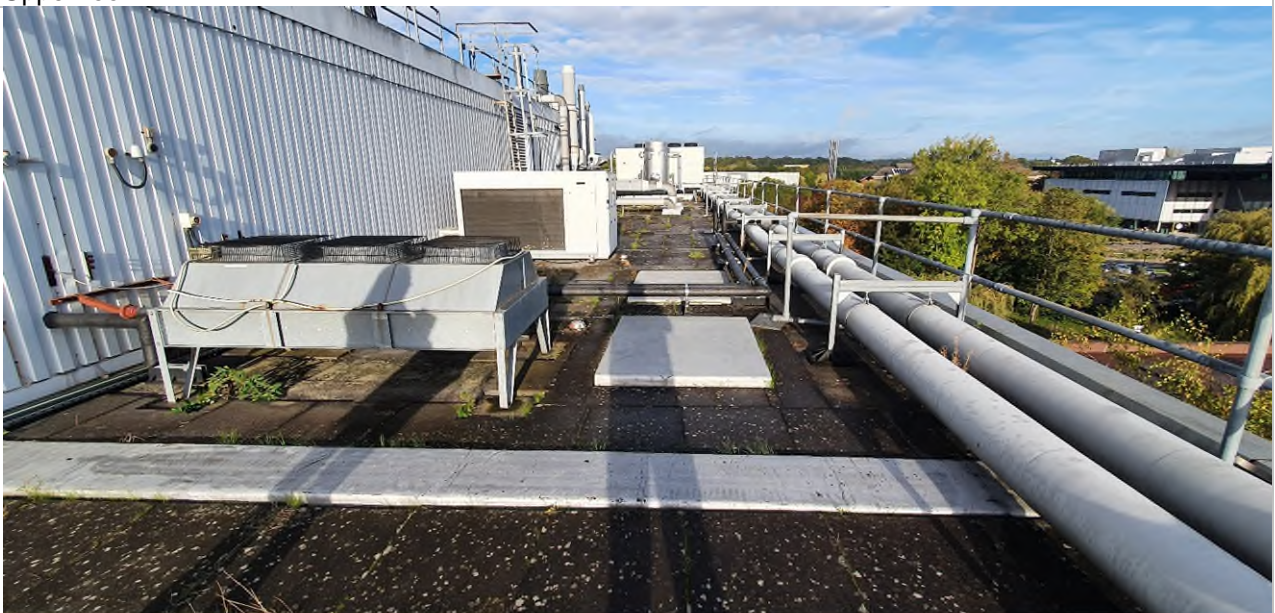
9.6. Bump hazards: There is a lot of plant on the north-westerly end of the roof, so care must be taken when navigating between it, under pipes and ductwork etc.

Main roof; plant and trip hazards
