Flat Roof Pre-access Hazard Identification Report

02.004 GIBBET HILL MAIN BUILDING

Date undertaken: 7th December 2023

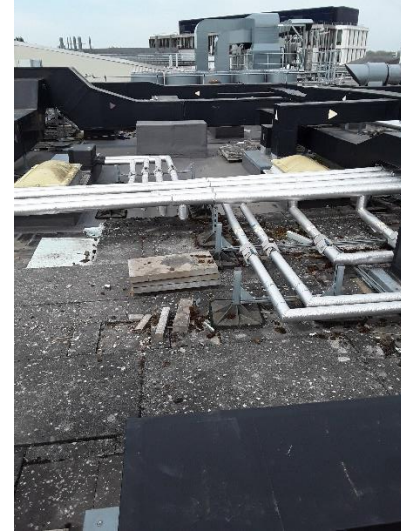
<p>Roof pipework and plant with gantry</p>	<p>Pipework that shows signs of damage as there is no gantry over them.</p>

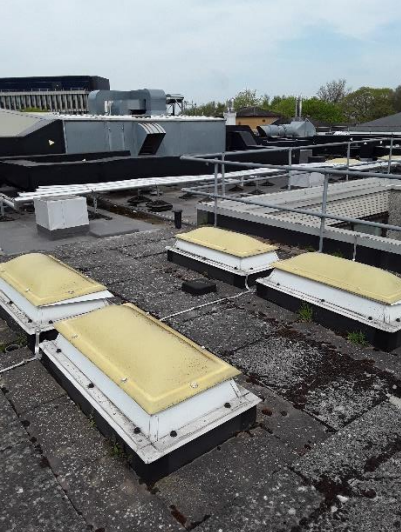
Sky lights

9.5 Falls and trips onto PV Panels, skylights, cable trays and other plant. Under no circumstance should the PV panels or skylights be stood upon.

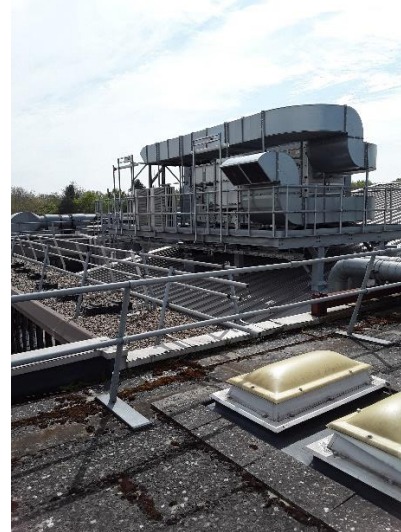
Edge protection, sky lights and plant

9.4 Falls from height; whilst there is edge protection in place, consideration should be given to the potential for falls from height in terms of operatives, materials and tools, especially in high winds.

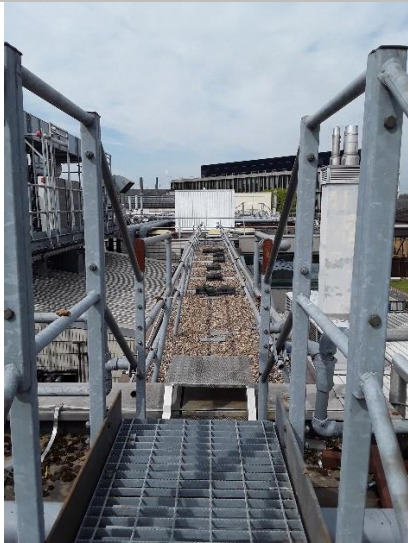
Walkway with loose ballast

9.2. Slips, trips and falls around the site. There are no set out walkways for this roof, it is open plan. The roof flooring comprises slabs and there are areas where slabs have been removed or come loose that may cause trip hazards. There are gantries available for traversing across some of the plant and services. There is also a small part of the roof that is made up of loose ballast which can become unstable underfoot.

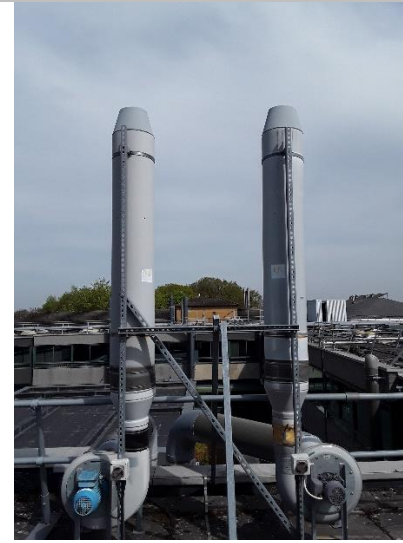
Typical Lab flues

9.8 Lab gasses – There are several flues which exhaust potentially toxic chemicals. There are no departmental restrictions or permits in place for these as they discharge at a safe height, but care should still be taken when working in close proximity to these.

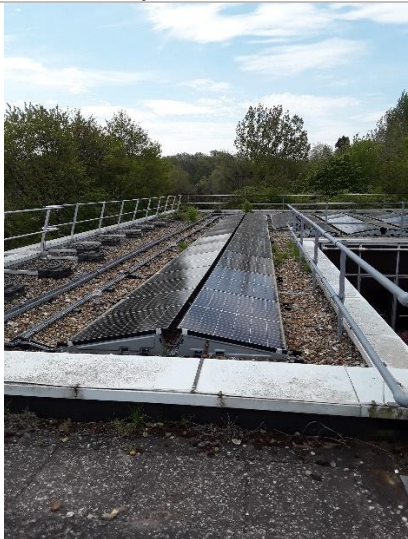
PV Panels loose ballast

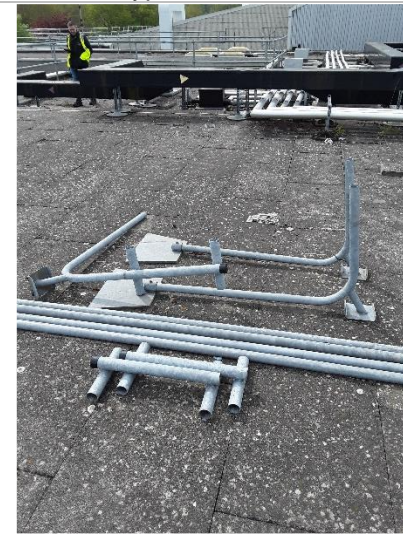
Abandoned equipment

5.5 Waste must be collected and disposed of appropriately by the Competent Person. If the Competent Person is an external contractor, they should remove any waste from the site and dispose of it according to their company policy. University employees should remove any waste or redundant equipment from the roof area and dispose of it according to University policy and guidance.
