Improving Thermal Comfort in Low-income Tropical Housing: The Case of Uganda

CONFERENCE PAPER · SEPTEMBER 2015

Hashemi, A., Cruickshank, H., Cheshmehzangi, A. (2015). Improving Thermal Comfort in Low-income Tropical Housing: The Case of Uganda, ZEMCH 2015 International Conference, 22-25 September 2015, Lecce, Italy.

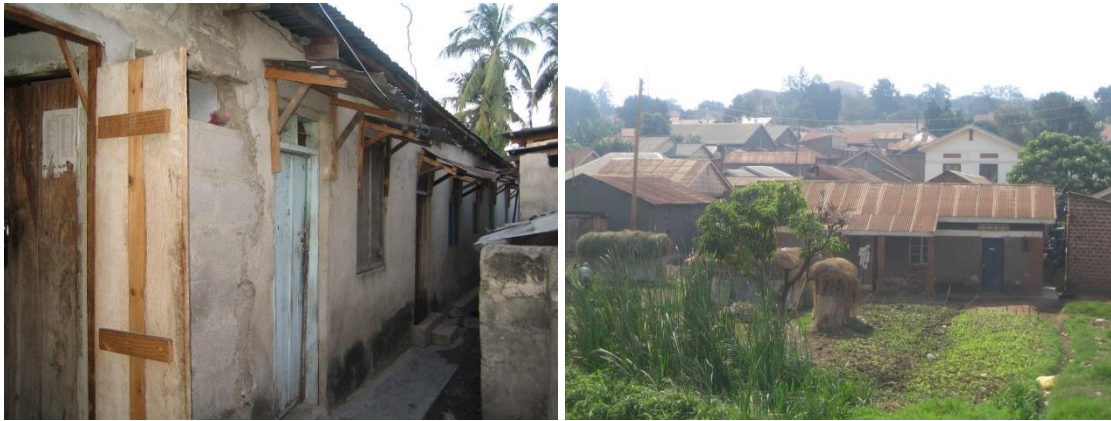
Figure 1: low-income housing with iron sheet roofing.

Figure 1 below also summarises the most common construction methods and materials used in housing projects during 2002-2010. In 2010, around 62% of homes in Uganda (84% in urban areas and 57% in rural areas) were roofed with iron sheets (Figure 2) followed by thatched roof which took a share of 37%. Around 57% (84% urban and 51% rural) of all dwellings had brick walls and 39% (12% urban and 46% rural) were made out of mud and poles. More than 71% of floors were made from earth (25% urban and 82% rural) and 27% (71% urban and 17% rural) were covered with cement (NPA 2010; UBOS 2010).

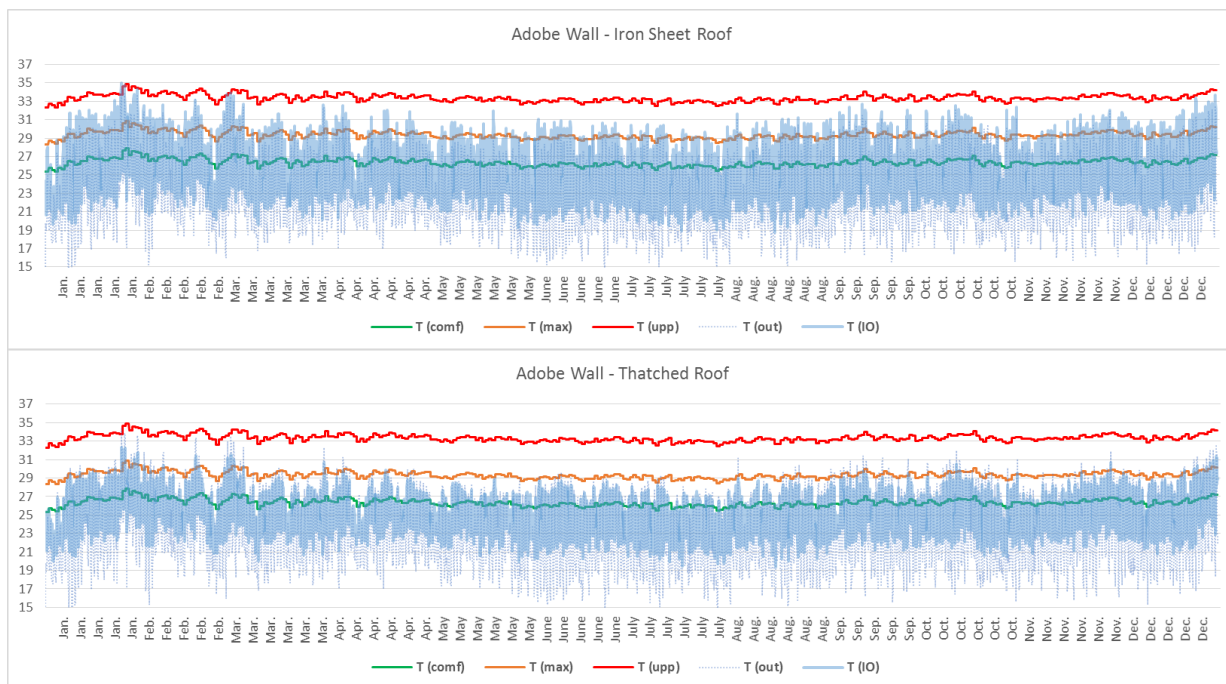
Figure 3: Thermal comfort condition for adobe walls with iron sheet (top) and thatched roofs (bottom).

Adobe walls with iron sheet roof failed all three TM52 thermal comfort criteria. Regarding the first criterion, the indoor operative temperature was for 8.4% of the occupied periods by 1 K or more

above the limiting maximum acceptable temperature. The building also failed criterion 2 (the daily weighted exceedance W_e) as for 65 days (17.8% of occupied days) W_e exceeded the limit of 6 degree-hours. As to criterion 3 (ΔT exceeding 4 K), the results reveal that there were six hours during which ΔT exceeded the “upper limit temperature” (T_{upp}). The situation considerably improved for adobe walls with thatched roof. The building passed both criterion 1 (0.6%, 1 K or more above the maximum acceptable temperature) and criterion 3 (ΔT , 0 hours exceeding T_{upp}) but marginally failed criterion 2 by only 3 days during which W_e exceeded the limit. Overall, the building seemed to be much more thermally comfortable compared to the previous roofing method (iron sheet roof). Figure 3 shows the thermal performance of the building during the entire year for thatched and iron sheet roofs with adobe walls.

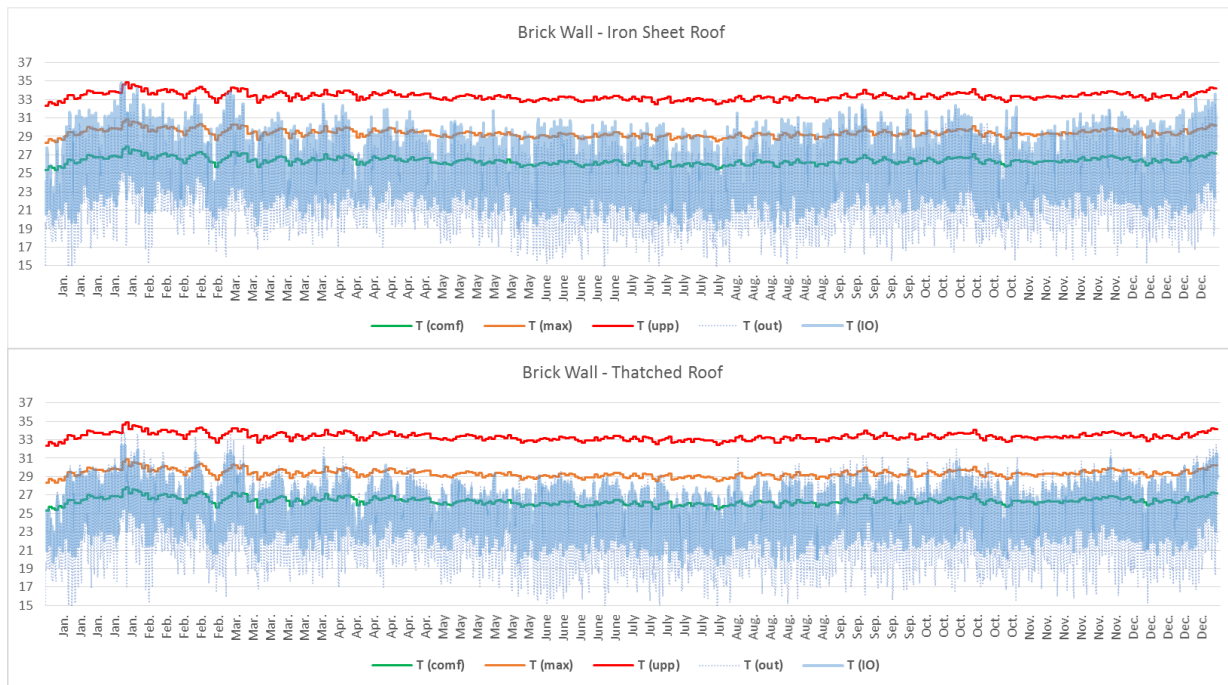
Figure 4: Thermal comfort condition for brick walls with iron sheet (top) and thatched roofs (bottom).

The results of simulations revealed that adobe and brick walls had similar performances although brick walls performed marginally better than adobe walls with iron sheet roof and slightly worse than adobe walls with thatched roof. Similar to adobe, brick walls with iron sheet roof failed in all three thermal comfort criteria. The building was thermally uncomfortable as the indoor operative temperature was in 8% of the occupied periods above the maximum acceptable levels. Moreover, for 56 days, W_e exceeded the acceptable limit. Regarding the third criterion, there were two days during which ΔT exceeded the maximum acceptable temperature by more than the 4 K. Similar to adobe construction, the situation considerably improved for the thatched roof. The building passed criterion 1 and criterion 3 but failed in criterion 2 as there were 5 days during which W_e exceeded the acceptable limit. Figure 4 summarises the results of simulations for brick walls with iron sheet and thatched roof constructions.
