Flat Roof Pre-access Hazard Identification Report

01.016 INTERNATIONAL HOUSE

Date undertaken 4th December 2023

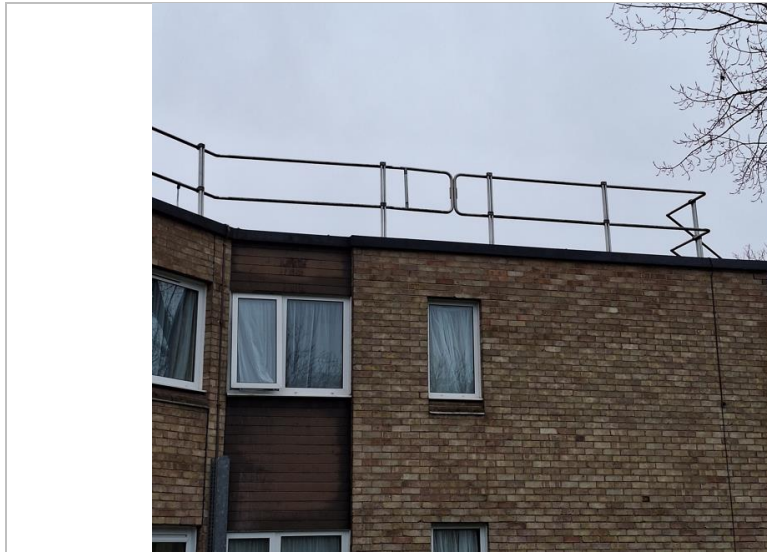
Roof access gate

9.8 The only access to the roof is via scaffold from the ground and through a turnstile built into the edge protection.

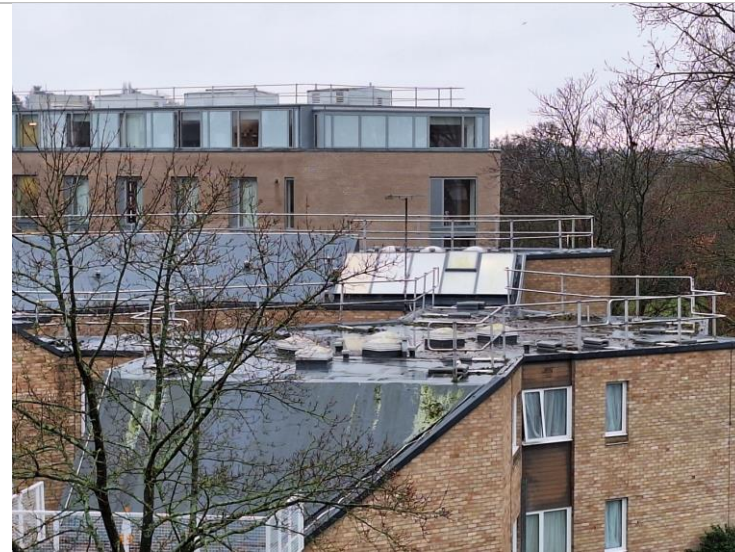
Sky lights and edge protection and roof incline with latchline system

9.6 Parts of the roof has no edge protection and are at an incline, however, there are mansafe/latch line systems in this area that must be used. The Competent Person must have evidence of training in the use of man safe systems and the correct personal equipment for their use. The Competent Person must have assurance that the lines have been inspected and certified safe to use before latching on to them.

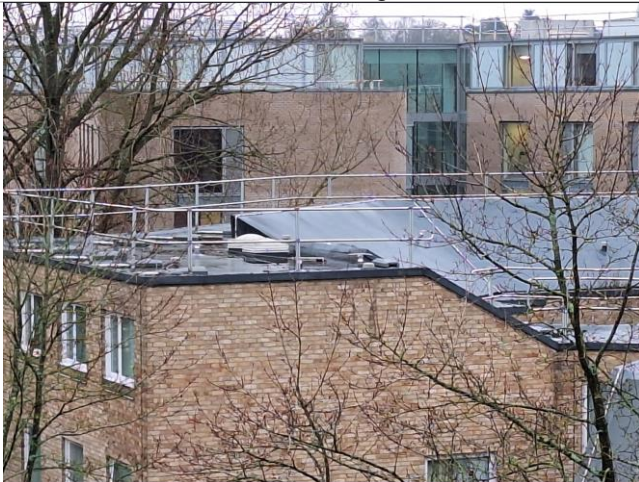
Roof incline and sky lights

9.5 Falls and trips onto skylights, cable trays and other plant. Under no circumstance should the skylights or any other plant be stood upon.

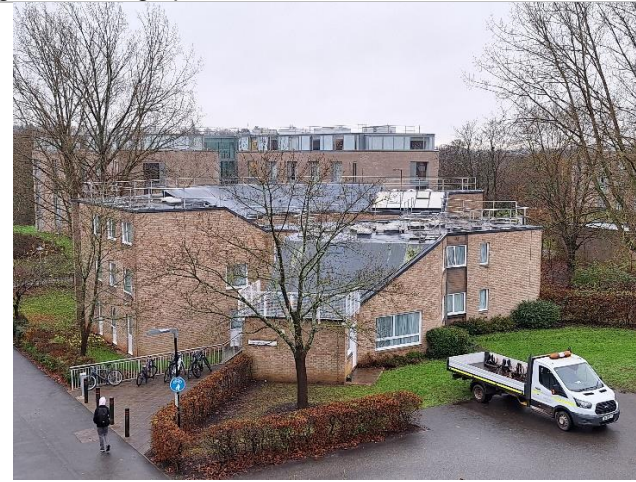
Whole roof
