## **Flat Roof Pre-access Hazard Identification Report**

### **01.423 Faculty of Arts Building (FAB)**

Date undertaken: 19<sup>th</sup> November 2021

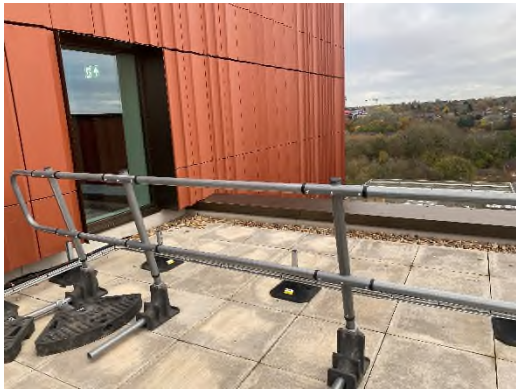
There is a gap of around 2 metres between the edge protection and the edge of the building.

9.1 There is edge protection to this roof however it does not meet the very edge of the building, there is around a 2 metre gap between the edge protection and the edge of the building. There is no plant equipment within that area and access to that area is prohibited unless the correct equipment and full fall arrest is in place. This needs to be fully explained in a RA and method statement before a permit would be granted to work in that area.

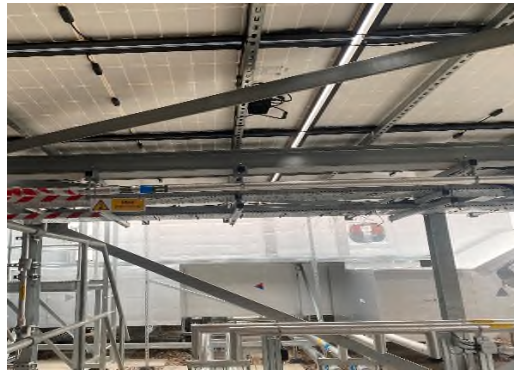
Some plant equipment is under cover, take care when crossing gantries in this section as some plant equipment is low level.

7.4 Some plant equipment is at eye level, for plant equipment without edge protection there is a need to take care when navigating around these areas to ensure clearance of sharp edges. Some plant equipment is under cover and there are gantries in this area which can make it difficult to avoid coming into contact with low level plant equipment.

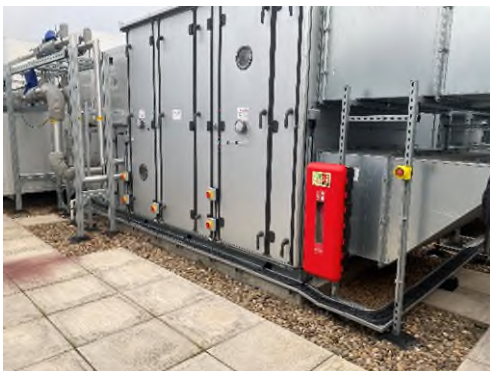
Fire detection devices and safety equipment are in place on the roof space.

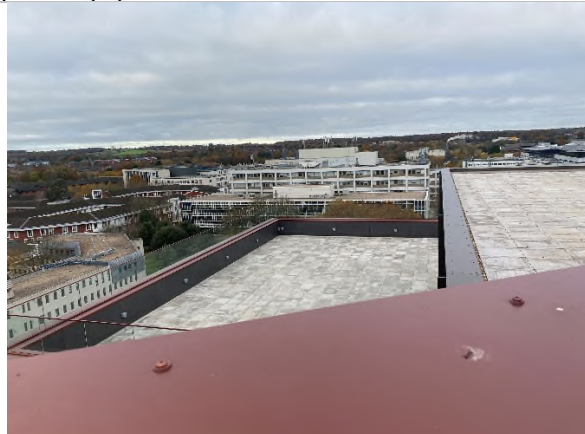
The balcony areas have edge protection/parapet walls but it is not safe to stand, kneel or lean on or use in any way as an anchor point. This should be looked at separately to any roof permit to assess any risks to working in this specific area.

- As well as the main flat roof space there are a number of balconies as a feature of this building. Although there edge protection on all of the balcony areas, under no circumstances should you sit, kneel or stand up on these ledges in case of fall. These are not suitable for use as an anchor point either. You will need a permit to access the roof space at the top of the building. You would need to liaise with the department lead should you need to work on the balcony area as many of them back onto office spaces and are used as meeting spaces.
